CAR-19
Marblehead
Ridgely
Private

National Register of Historic Places Registration Form

Marble Head, CAR-19	
Name of Property	_
Caroline County, Maryland	
County and State	_

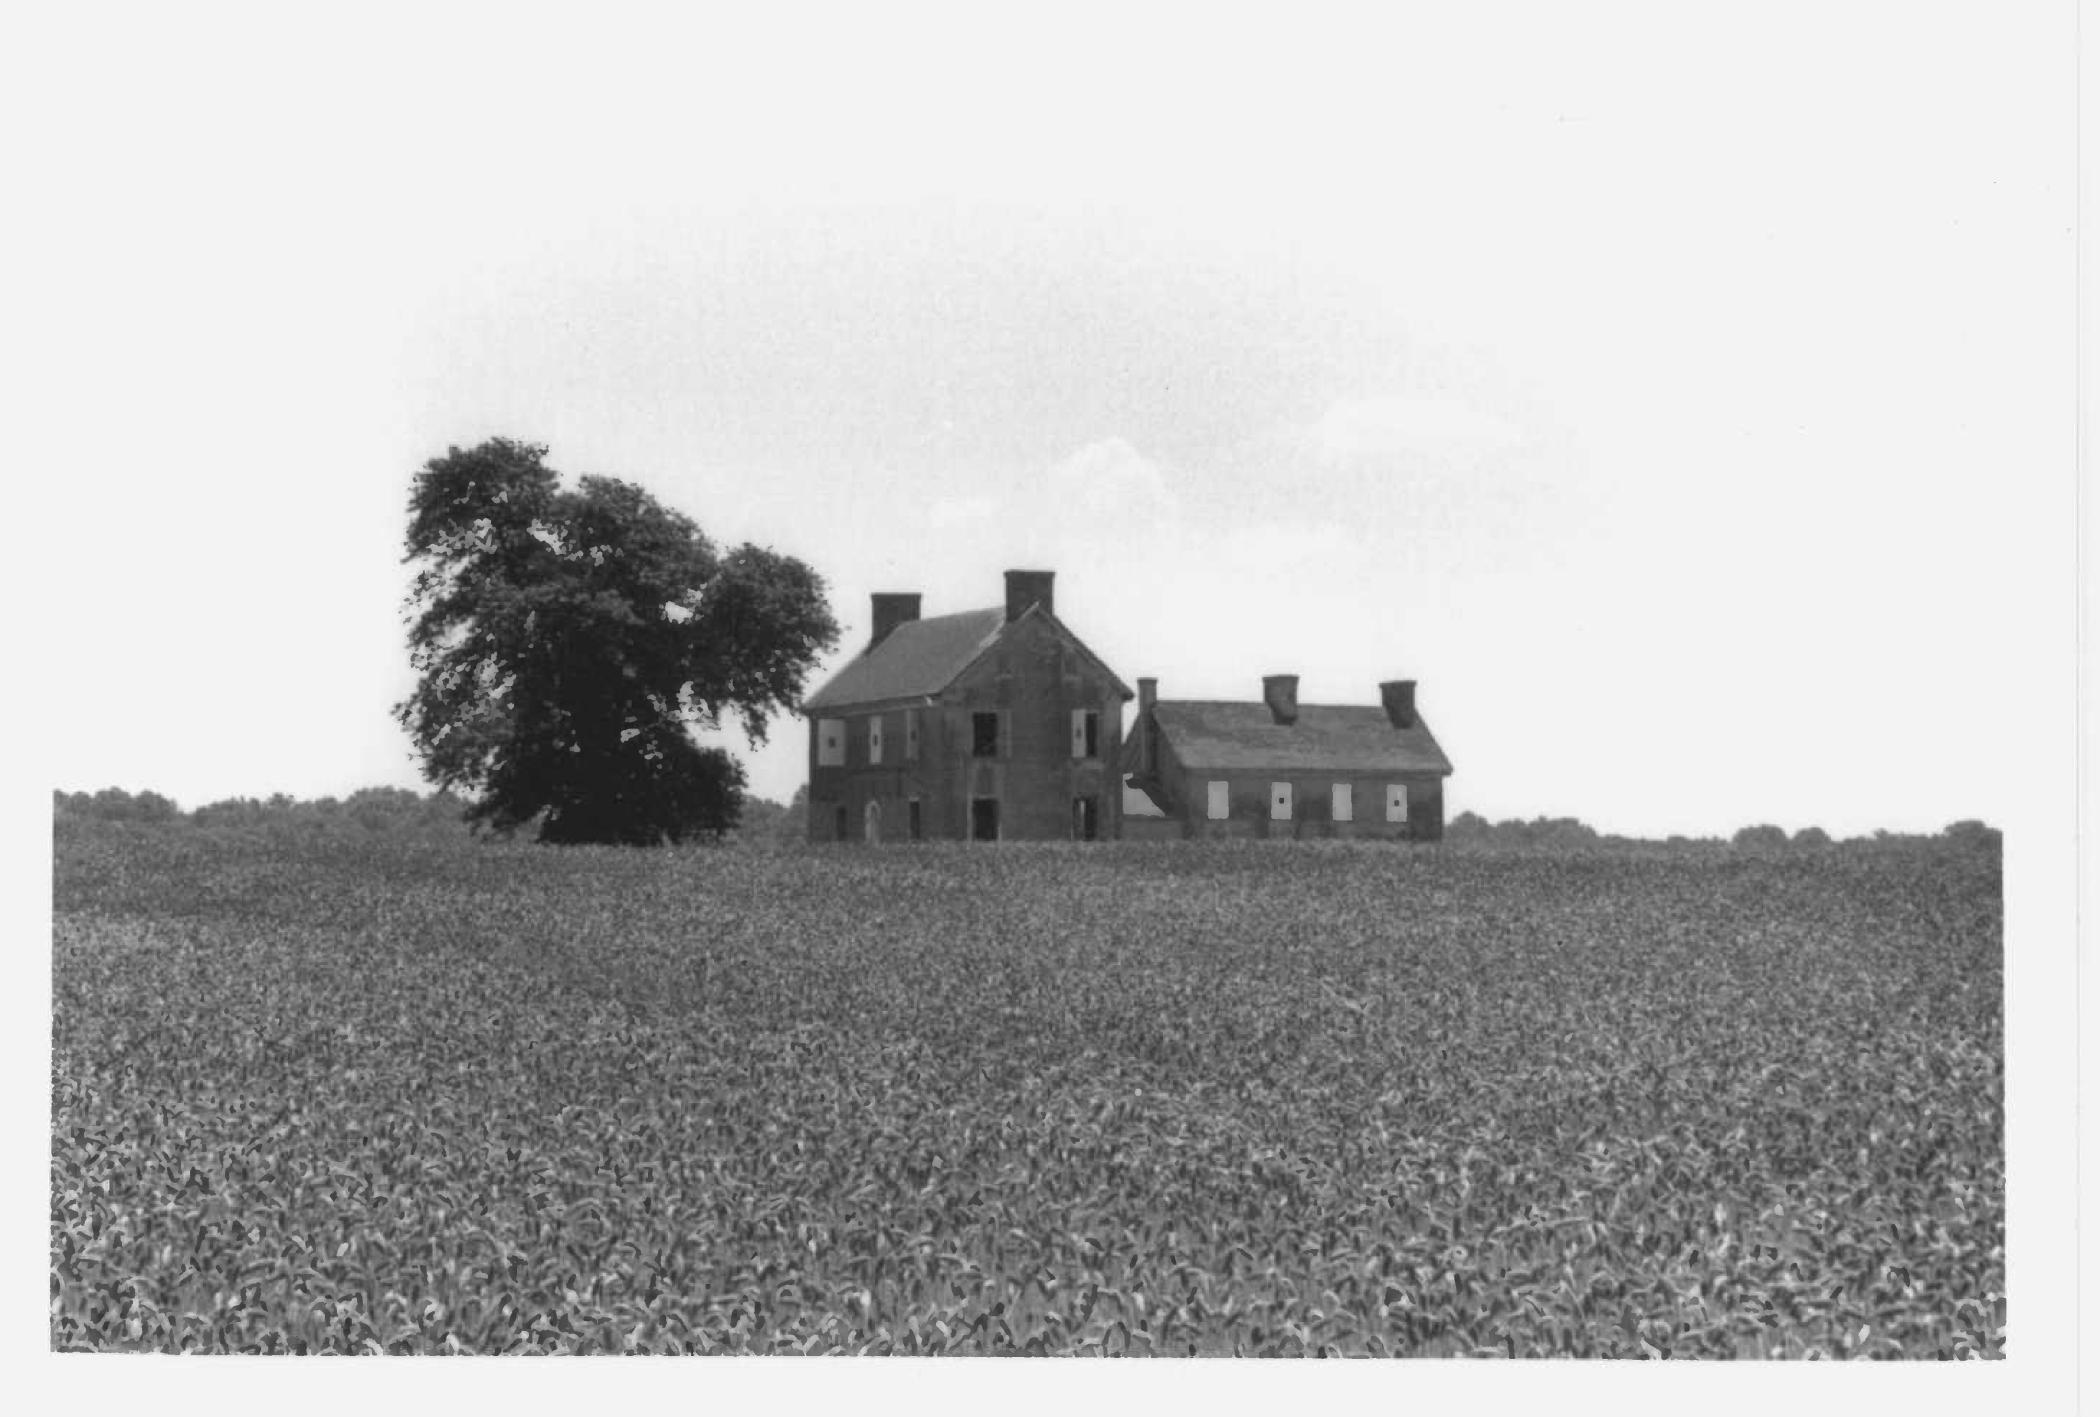
1 04 22

NORTHWEST ECEVATION

The northwest gable end is defined by a pairs of boarded over window openings on each floor which flank the interior end chimney stack. Small window openings light the attic. The late nineteenth-century eave is extended with an enclosed soffit and returns at the base of the roof. The southeast gable end is similarly treated, however a single window opening defines the first and second stories.

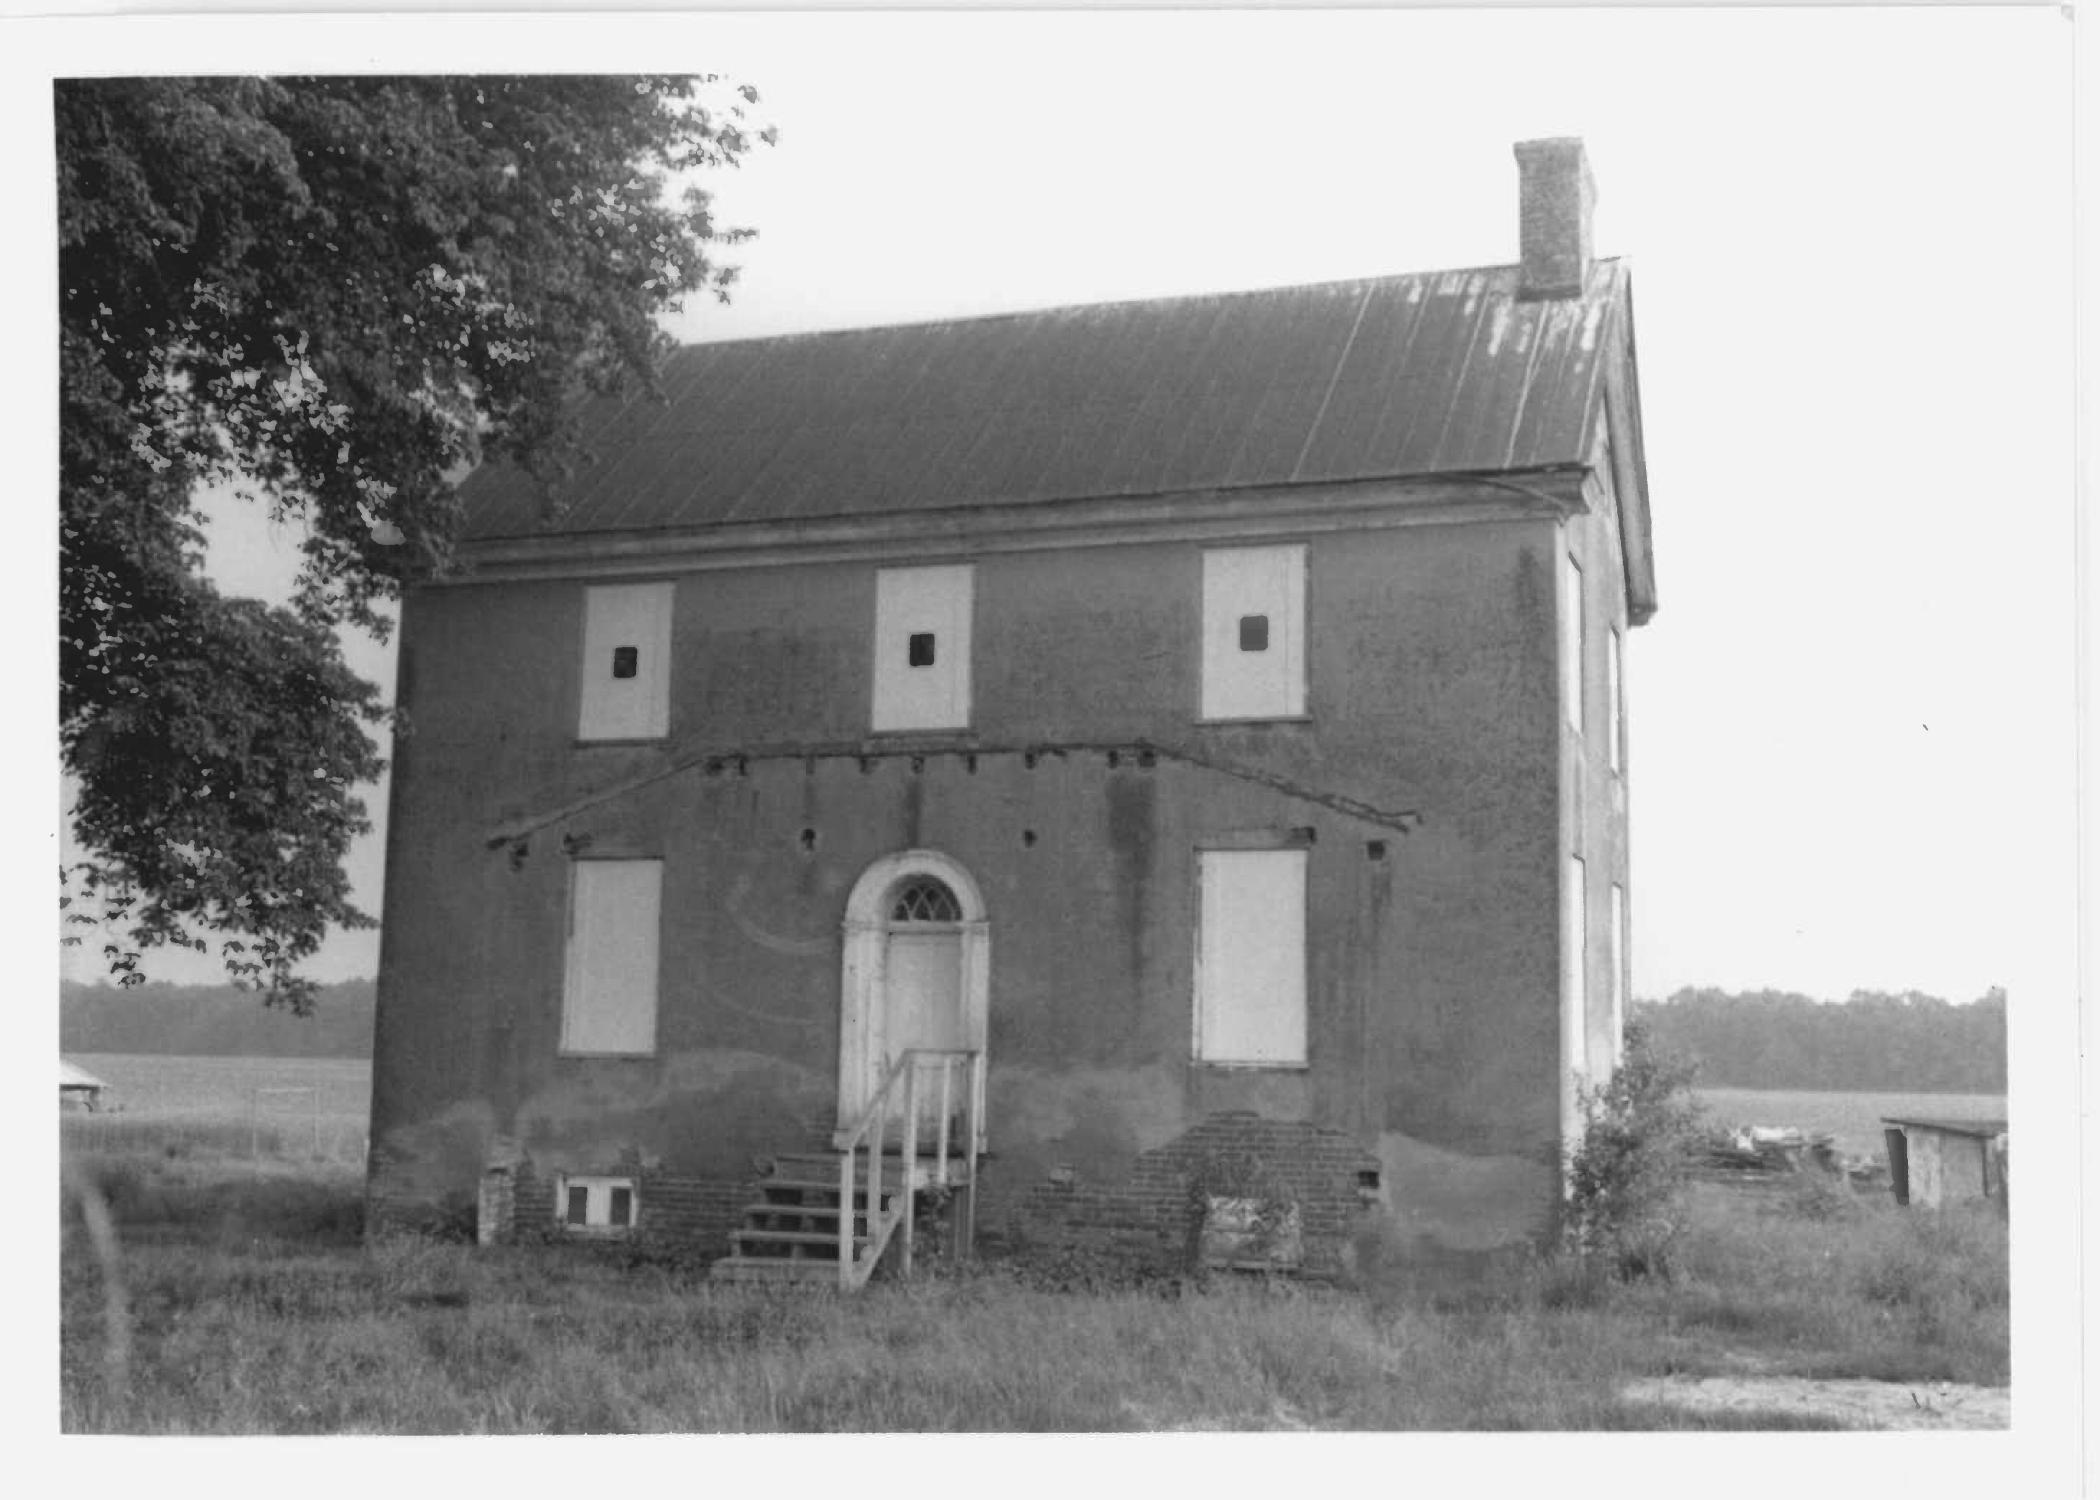
CAR-19 MARBLE HEAD RIDGELY VIC., CAROLINE Co., MD. NORTHEAST ELEVATION 5/01, PANC TOWART, PINOTOGRAPITER 4 04 22

Supported on a raised cellar of common bond, the two-story, three-bay main block has a symmetrical northeast (main) elevation with a center, round arched entrance and flanking window openings. The round arched entrance is enhanced with early nineteenth-century finishes that include fluted pilasters, raised-panel reveals and soffit, and a pointed arch muntin design which fills the half-round transom. The four-panel front door dates from the late nineteenth century. The adjacent window openings were reworked during the late nineteenth century with two-over-two sash, which have been removed. Plywood board shutters have been installed over the window openings. The smaller second story window openings have been covered over as well. Two additional window openings light the cellar. The late nineteenth-century exterior stucco has an ashlar strike in an effort to imitate stone. Above the window openings the stucco was struck with a jack arch design. Where the stucco has flaked or worn off the Flemish bond of the main block is clearly evident and the mortar joint is struck, confirming that the stucco dates from a later period than initial construction. Trimming the base of the roof is a boxed cornice dating from the late nineteenth century. A hip roofed Victorian porch has been removed from the front of the house.

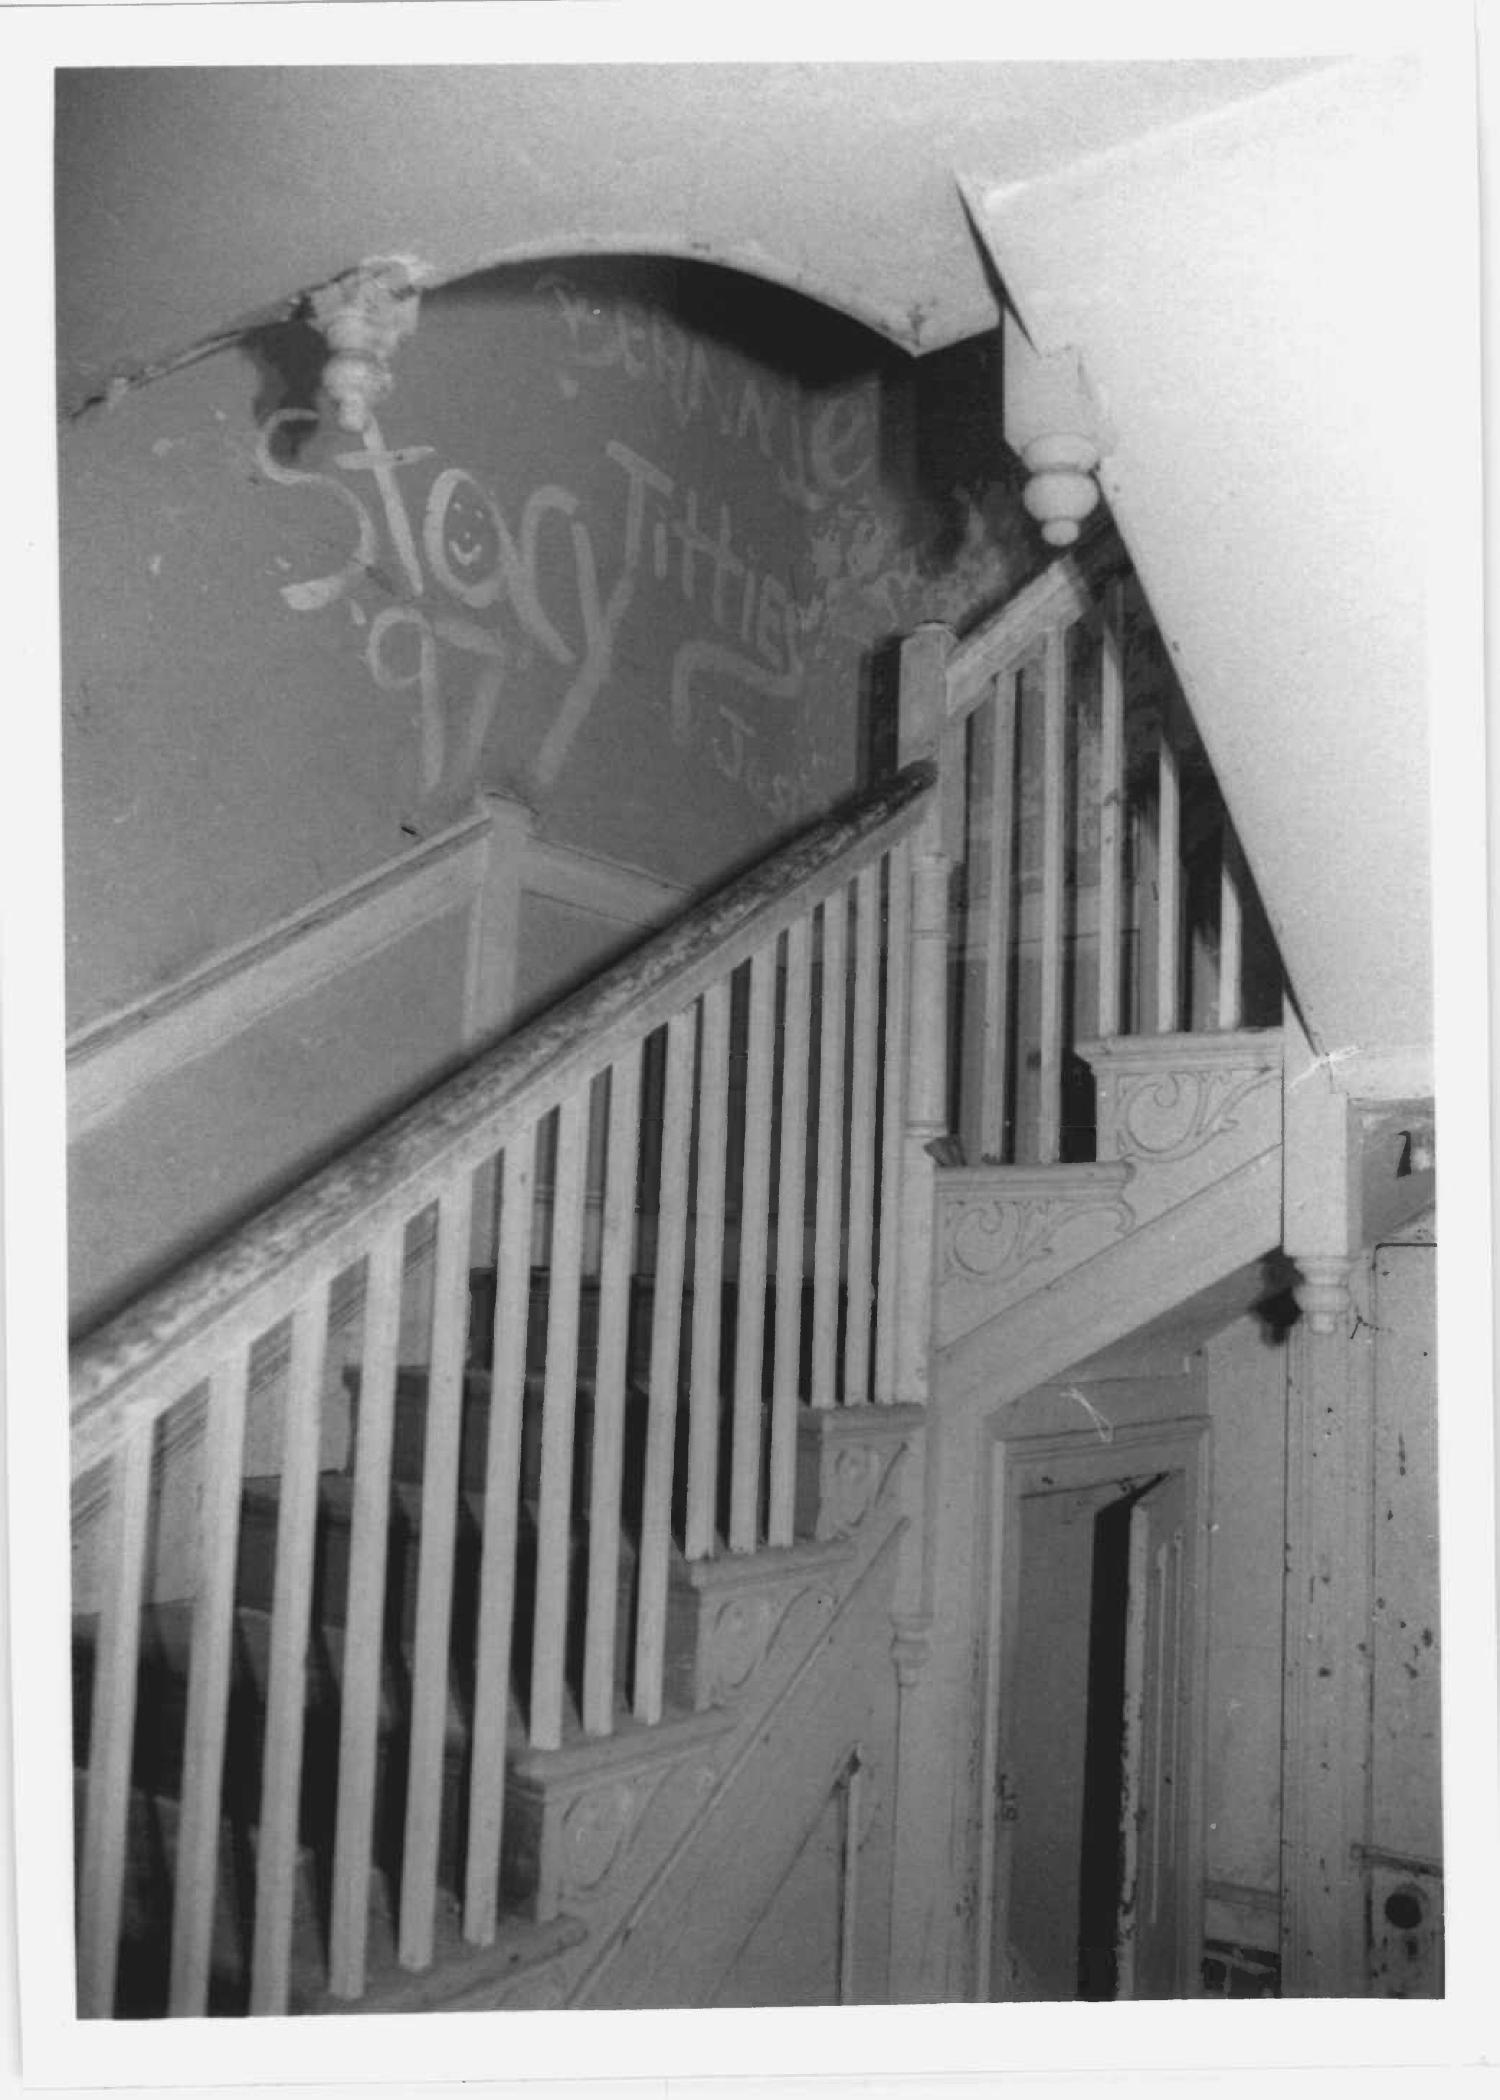
13 OF 22

KIRGERY VK., CANOLINE GI, MA.
CENTER ITAL, STANKERSE

The first floor interior retains a high percentage of its original woodwork. The center hall is dominated by a half-turn stair with landings. A turned newel post and a series of narrow rectangular balusters support a molded handrail. The stringer is embellished with a delicate scroll decoration, and the area under the stringer is finished in a large triangular raised panel. A raised four-panel door opens into a stair closet. The staircase is also distinguished by a half-rail imbedded in the adjacent plaster wall. Turned pendants hang from the bottom of each second floor newel post. The center passage is also trimmed with crossetted door surrounds, and early nineteenth-century chair rail and baseboard moldings. The interior finish of the front entrance has a molded keyblock within its arched, early nineteenth-century molded surround.

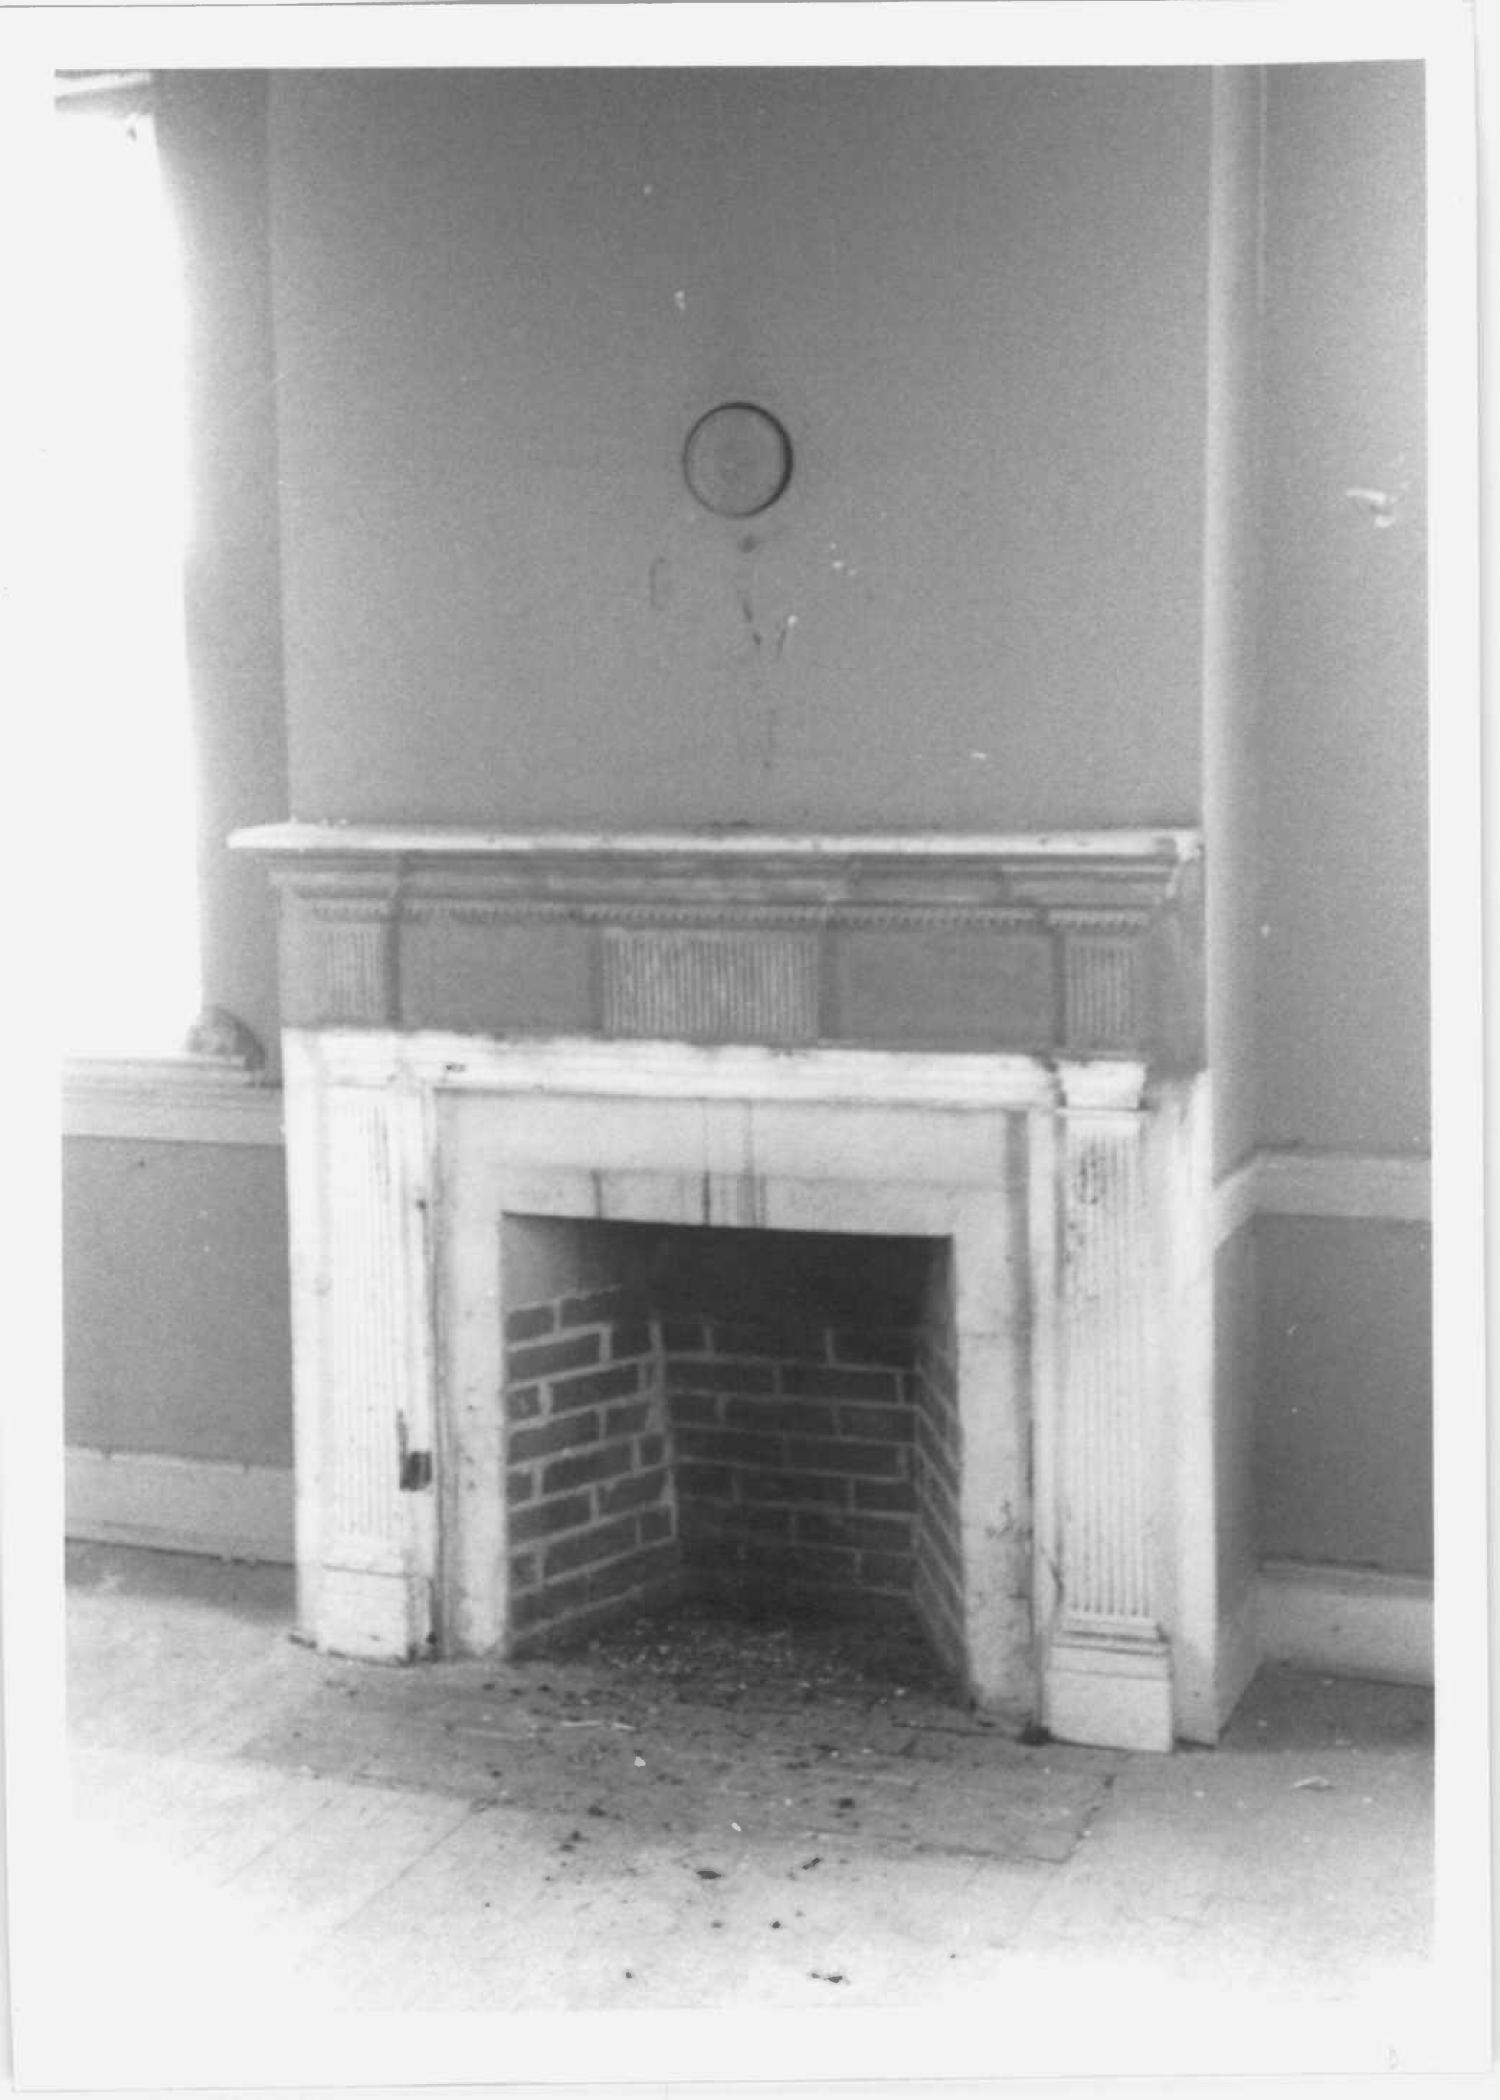
CAR-19
MANBUE ItEMS
RIDGERY VIII, COMMINE G. MA.
PARLOR
5701, PANL TOWALT, PITOTO.
14 OF 22

The adjacent parlor to the west features an original early nineteenth Federal mantel, as well as intact Federal chair rail and baseboard moldings. Fluted pilasters rise to a five-part frieze enhanced with three fluted blocks. Fixed atop the frieze is a delicately carved dentil row of molding under a stepped mantel shelf that follows a broken line coincidental with the projecting blocks. A later board shelf has been attached to the top of the mantel shelf. The hall retains its original plaster and flooring as well as a crossetted surround that frames the passage door opening. The Federal moldings were removed from each of the four window openings when the windows were replaced during the late nineteenth century.

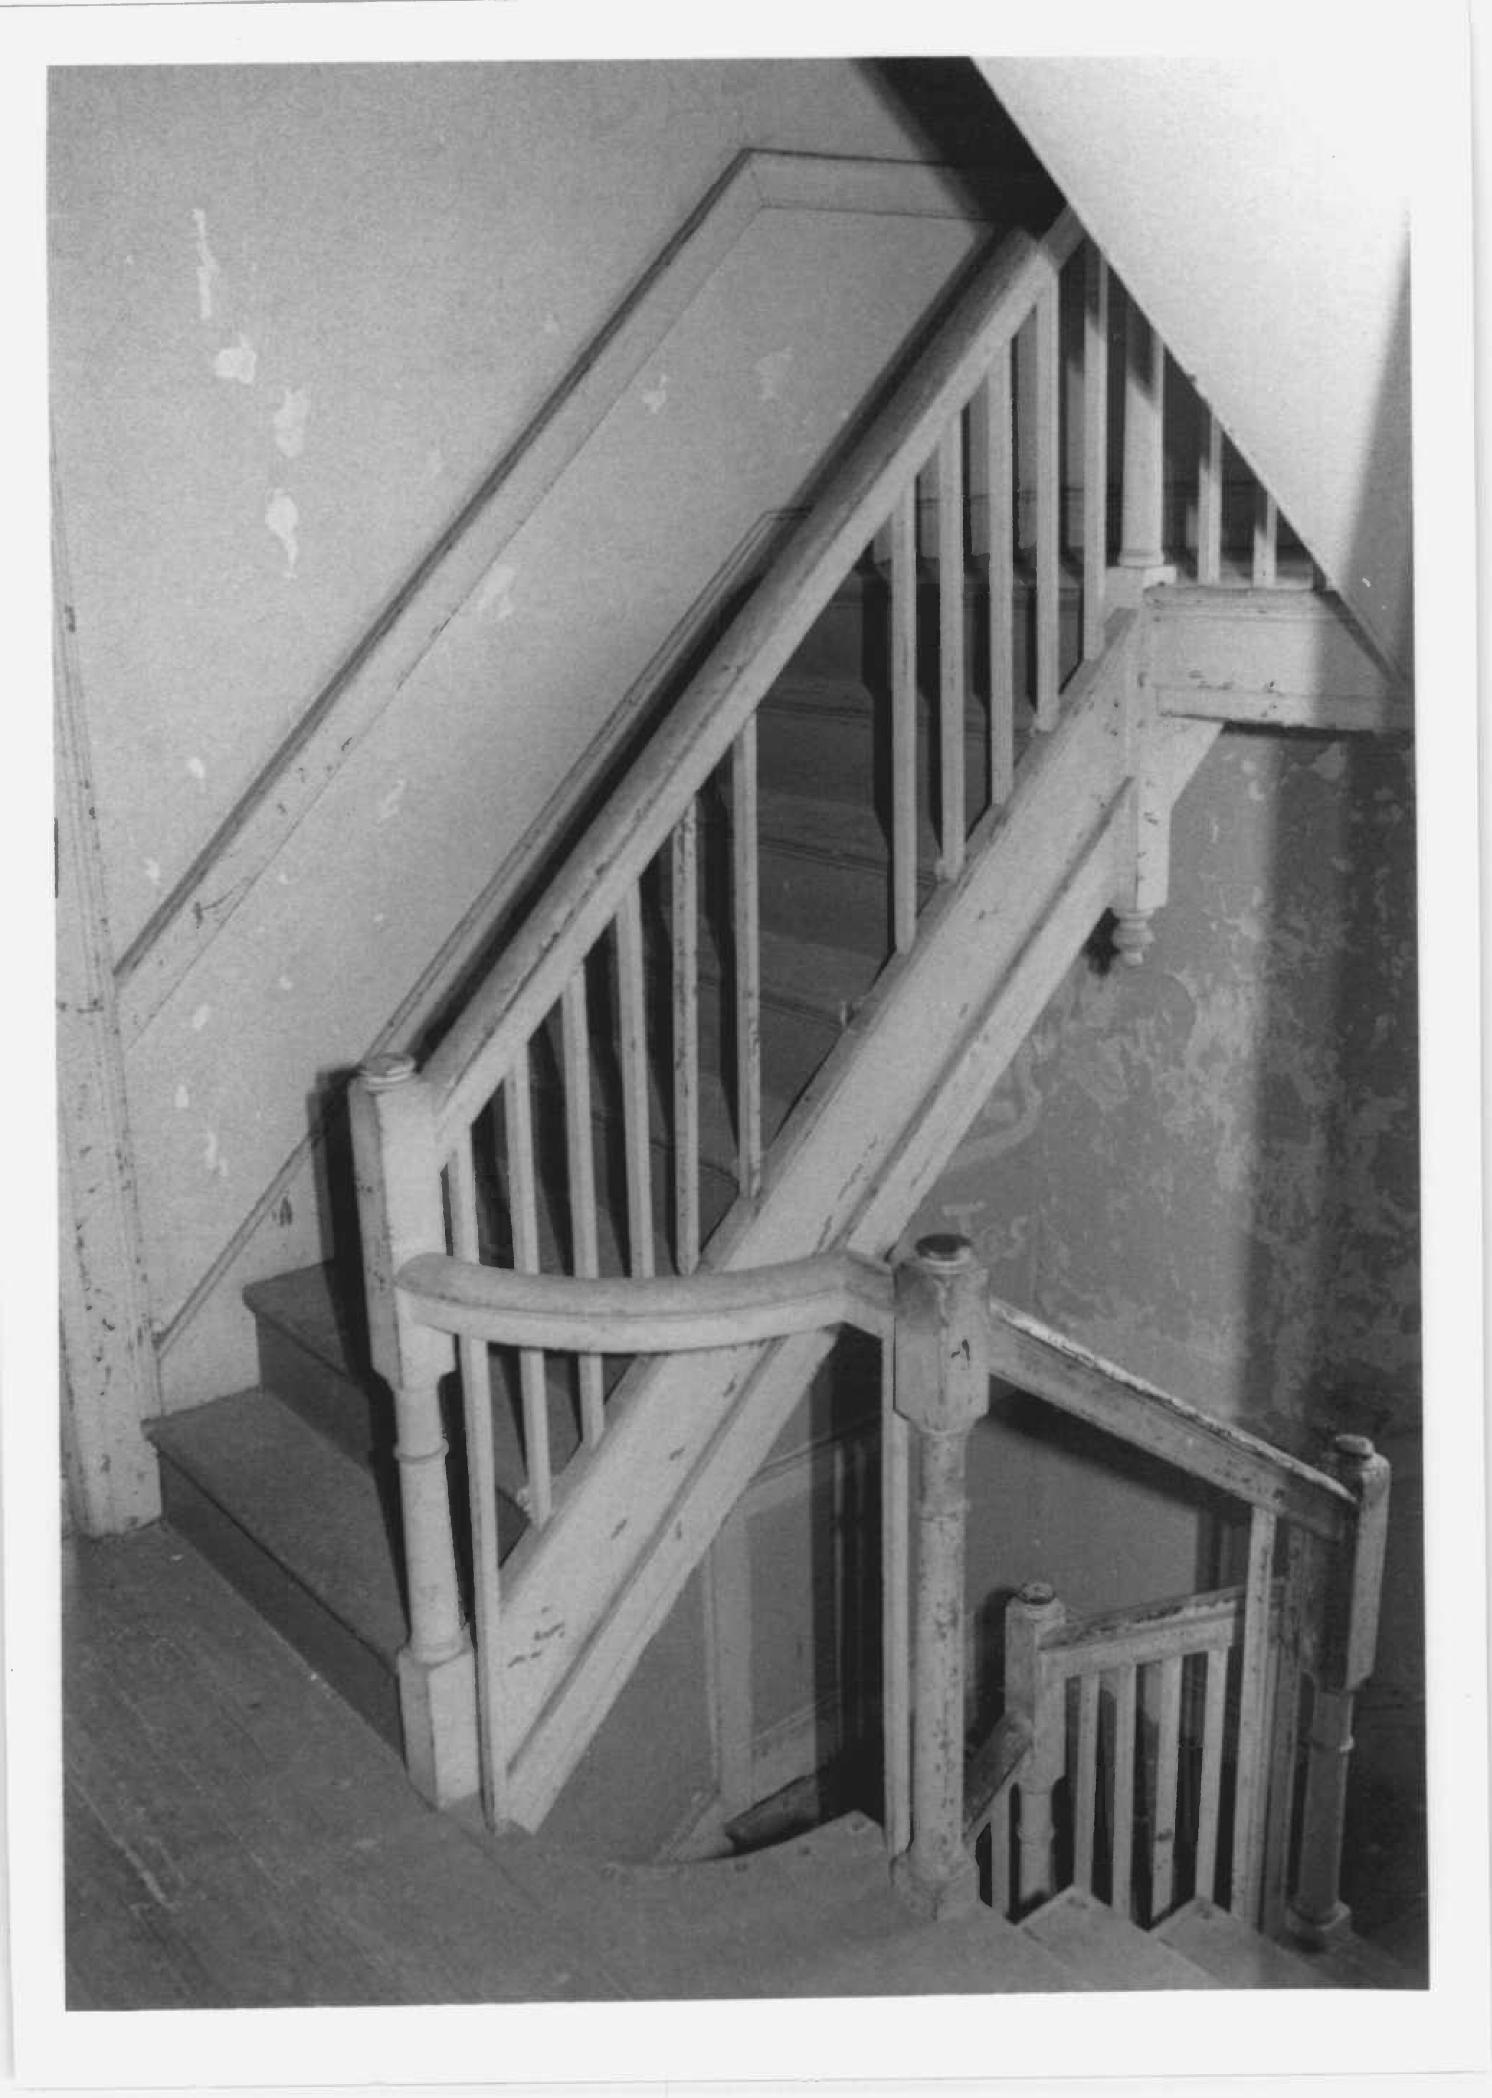
17 04 22

RIDGELY VIC., CANVEINE CU. MO.
SECOND FLOOR STANKETSE

The second floor of the main block retains most of its early nineteenth-century woodwork. The Federal staircase has an unusual curved section of railing at the second floor level. The turned newel posts and rectangular balusters support the molded handrail, which continues to the third floor.

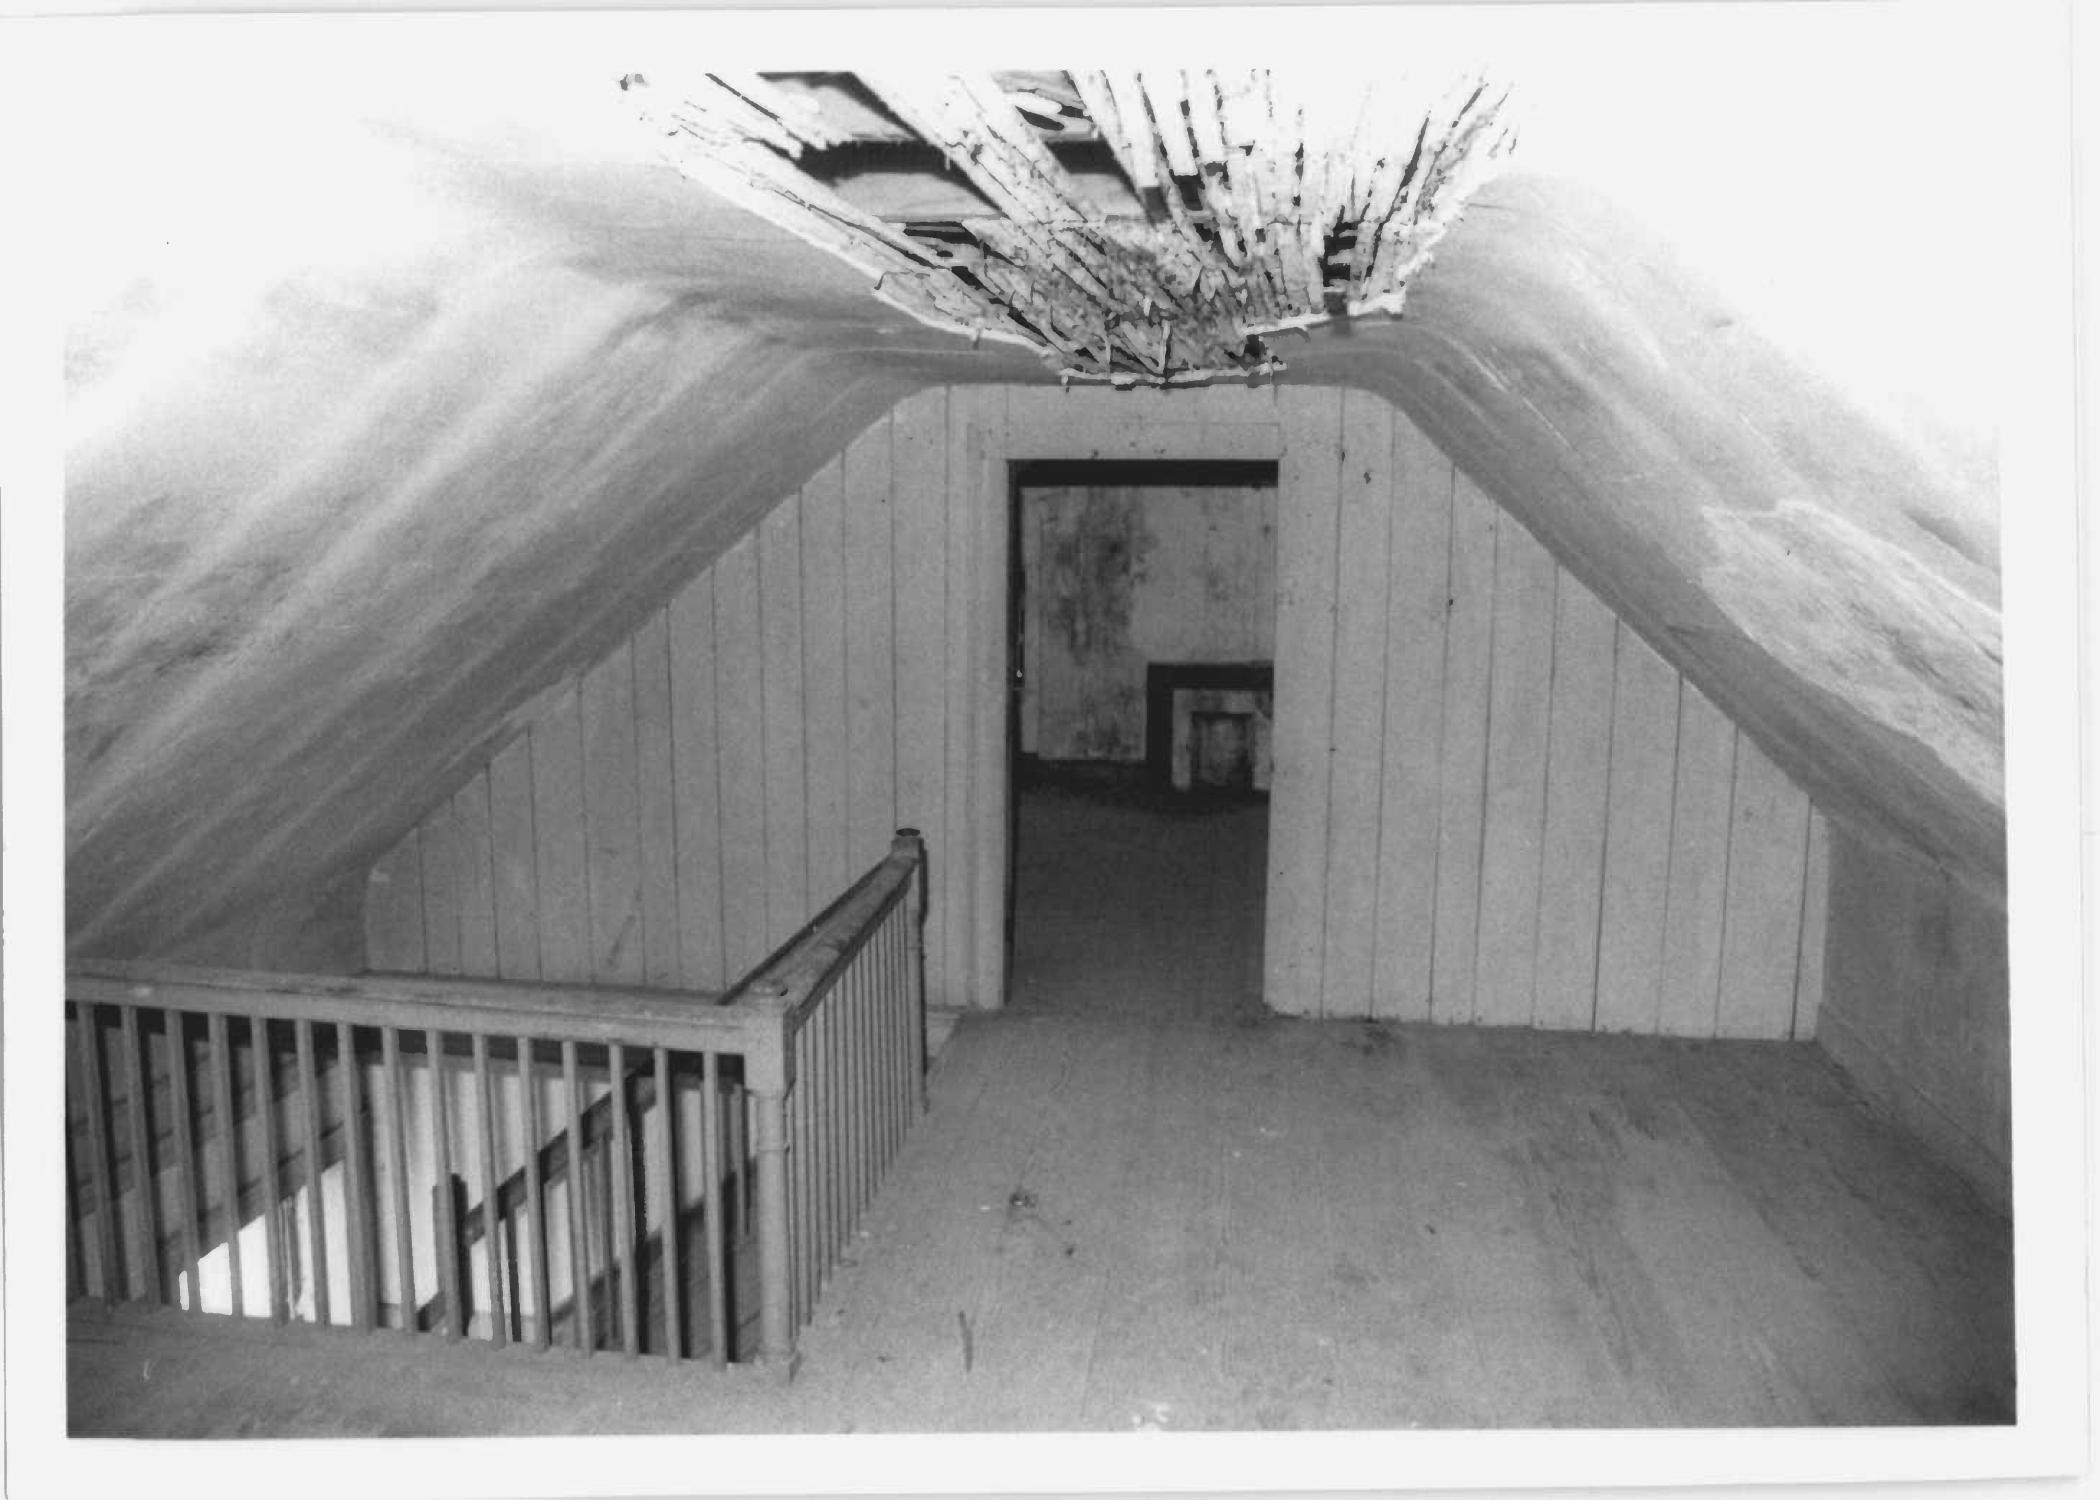
CAR-19
MARIE Items
RIPGERY VIC., CAMULINE CU. MA
ATTIC, STAR RALING AND BERMED BONNO
WINL
57 04 PANC TOWARS, PINITULA ARRIVELL
18 01 22

The third floor is finished with plaster walls and a vertical, beaded board partition that divides the space in two. The turned newel posts and rectangular balusters continue to support a molded handrail. The beaded board partition is pierced by a center door opening fitted with a raised six-panel door. The west room has a small fireplace framed by an early nineteenth-century surround. Although the attic is fully finished, missing sections of plaster reveal riven lath fastened with wrought lathing nails. Evident as well is the common rafter roof system.
